TITLE A Guidebook to FEMA 154--Rapid Visual Screening of Buildings for Potential Seismic Hazards. A Handbook for Use in the Screening of School Buildings.

FEMA 154 - RAPID VISUAL SCREENING OF BUILDINGS FOR POTENTIAL SEISMIC HAZARDS: A HANDBOOK

FOR USE IN THE SCREENING OF SCHOOL BUILDINGS

DECEMBER 1994

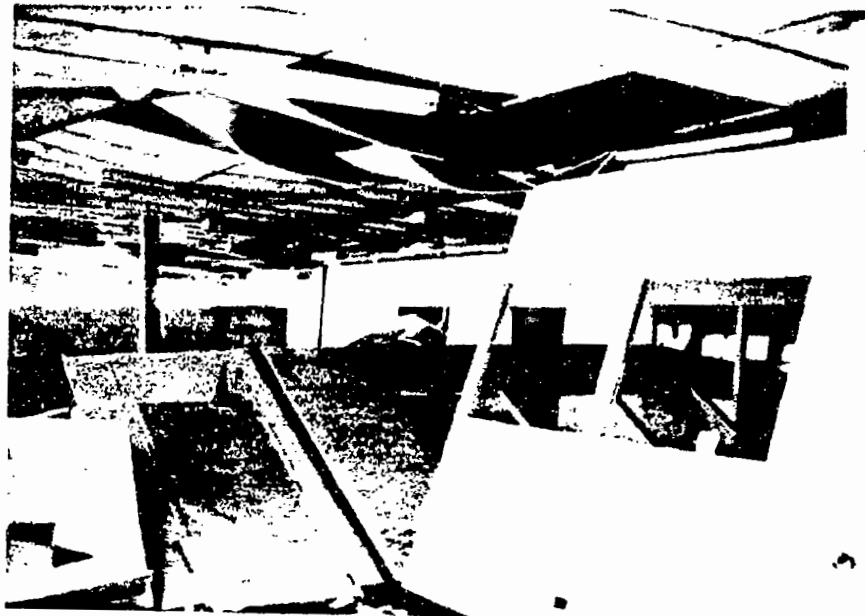
FIGURE 18
*Collapse of
interior structural
partitions.*

- Failure to use the large amounts of interior wall (classrooms, corridors) as redundant systems to the primary structural system and neglect of the influence of the relative stiffness of both systems (Figure 18).
- Use of limited numbers of columns (longer spans) in large open spaces (auditorium, cafeteria), causing these elements to become extremely critical.
- Discontinuity of the uniformity of the structural system through the location of large long span areas.
- Placement of openings (stacked, uniform classroom doors and windows) in the interior and exterior shear walls causing large forces to be concentrated in certain weak elements.

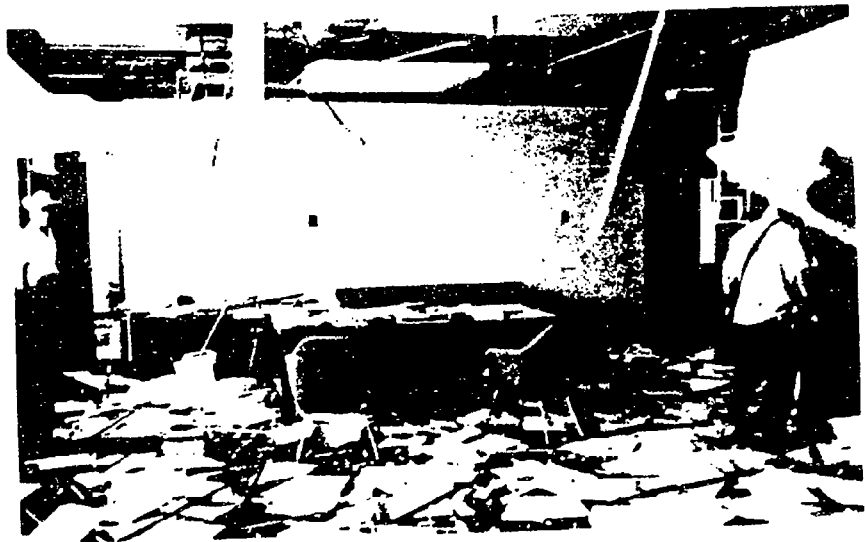
FIGURE 21
Ceiling/lighting system collapse.

Free-standing kitchen equipment and electrical equipment such as transformers, switchboards, emergency generators, and lighting fixtures can fall, causing injuries as well as fires (Figures 20-21).

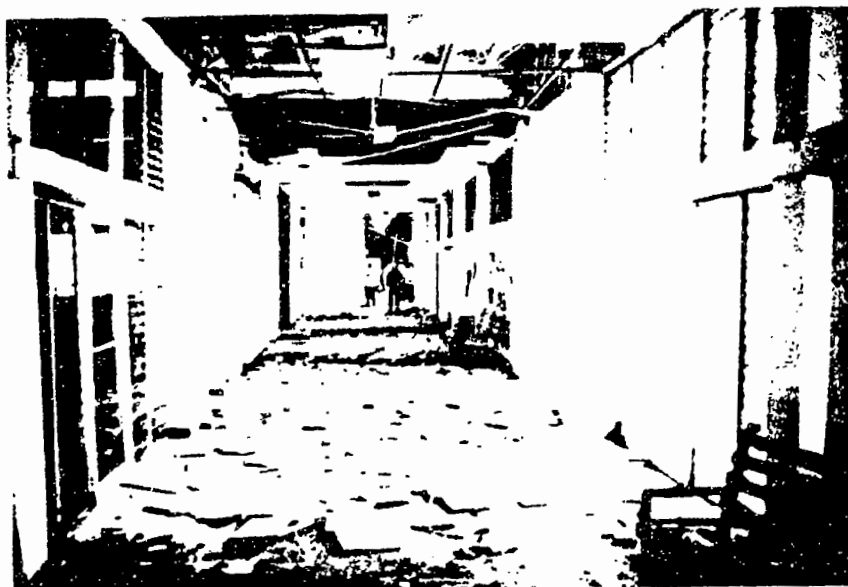
FIGURE 25
Blocked egress route.

Safe, direct, unobstructed exit routes should be planned so students and teachers can safely exit a school. Lockers, ceiling systems, lighting systems, ventilation systems, and windows that enclose these routes must be designed as critical components and be located so that their failure will not impede egress (Figure 25).
